# USING DESIGN-BUILD TO MITIGATE RISK TO A MAJOR WATER DELIVERY SYSTEM

ROCKY MOUNTAIN DBIA PRESENTATION MAY 20, 2016

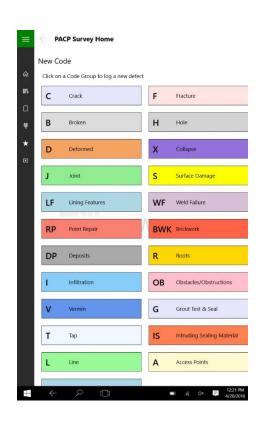
#### CONDITION ASSESSMENT METHOD

- ✓ Pipeline Assessment and Certification Program (PACP) of the National Association of Sewer Service Companies (NASSCO)
- ✓ 23 code categories
  - Structural
  - Operation and maintenance
  - Construction features
  - Miscellaneous
- ✓ Custom tablet application and database

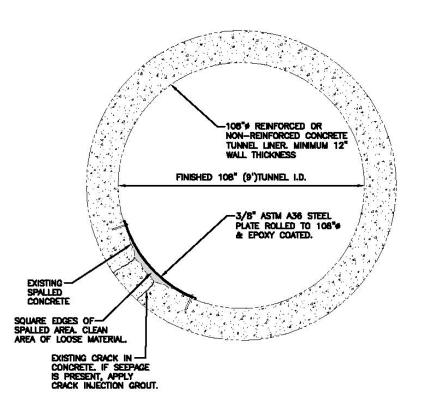
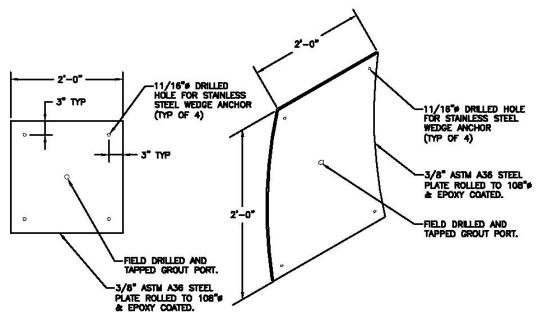
#### **CURRENT REPAIRS**

- √ 20 locations
- √ 44 2x2 plates, 20 2X4 plates
- ✓ Hydrophobic grout at 5 locations

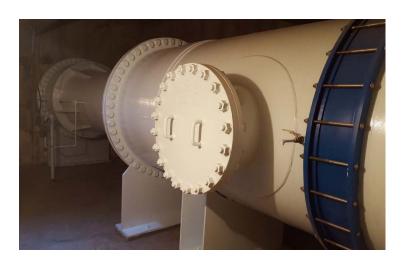
#### INSTALLATION CHALLENGES

- ✓ Train 1 elbow swap
  - No dimensional compatibility between trains
  - No fit-up tolerance
- ✓ Class 400 & 600 flanges
- ✓ Train 3 misalignment
- ✓ Not horizontally aligned

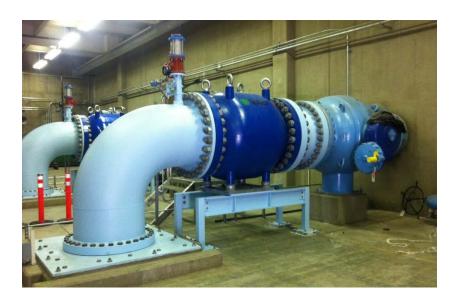
#### DB APPROACH

- √ Taped dimensions not accurate enough
- √ 3D survey implemented
- ✓ Shipped-loose, weld on flanges on lower pressure class downstream of PRV
- ✓ Cut-to fit elbow leg
- ✓ Air valves

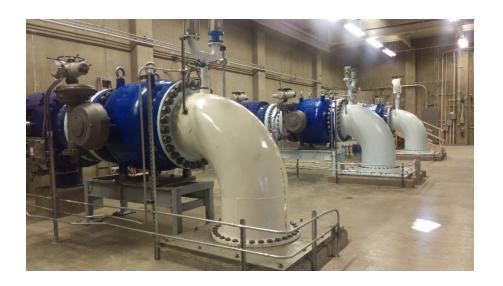
#### HYDRAULIC MODELING

- Cavitation in top leg of elbow at low flows
- ✓ Vacuum in discharge elbow
- ✓ Previous design had single air valve with isolation
- ✓ Previous design lacked surge analysis and recommend enabling ramping and interrupter of valve actuators

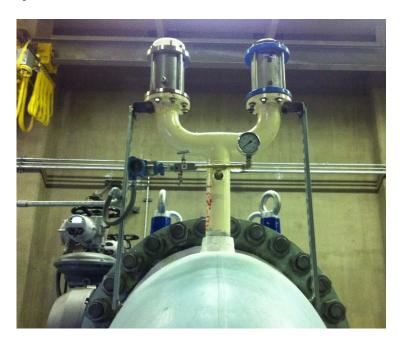
#### HYDRAULIC MODELING

- ✓ Implemented dual air valve header with no isolation
- ✓ Disabled ramping and interrupter
- Remote pressure reading
- ✓ Two valve manufacturers

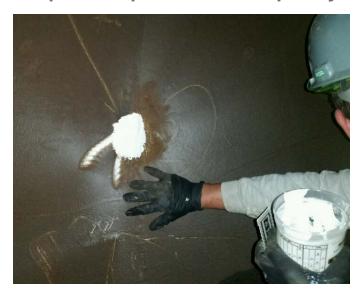
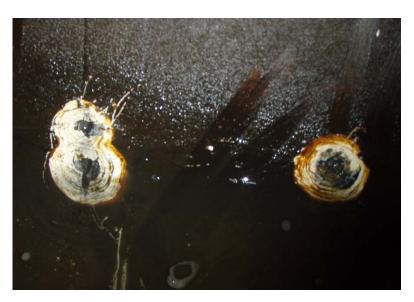
#### HEADER INSPECTION / REPAIR

- √ 96" steel header internally inspected
- ✓ Isolated locations of corrosion pitting up to 3/8"
- ✓ Short window before tunnel refill
- ✓ Spot repair with epoxy
